UNITED STATES ENVIRONMENTAL PROTECTION AGENCY
REGION V

SUBJECT: RCRA Facility Assessment
Chemetco Site Visit

TO: FMP File .ILD 048 843 809

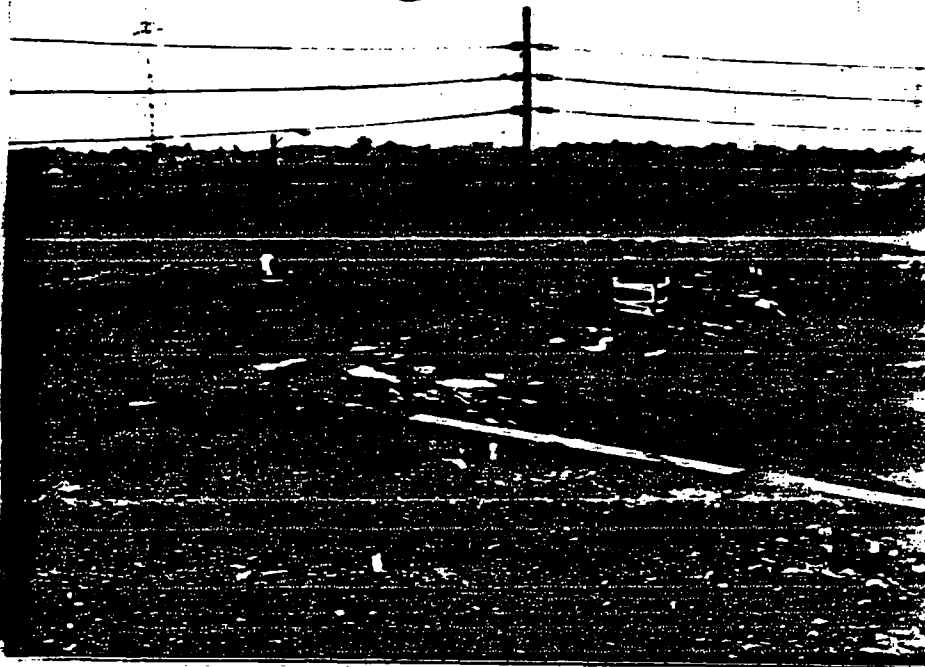
PROJECT/CASE NO: CHEMETCO SITE VISIT
SUBJECT: Area between Scrap Yard and Slag Pile (Northeast)
LOCATION: Northern side near facility's property line next to agricultural field
CITY: HARTFORD COUNTY: HARTFORD STATE: ILL
DATE: 5-28-86 TIME: 11:15 AM
WEATHER: (SUN) (HAZE) (CLOUDY) (RAIN) (SNOW)
PHOTOGRAPHER (S): Joel McKell from Chemetco
WITNESS: James E. Goff & James Mayka
CAMERA: CHEMETCO'S PROPERTY
FILM TYPE: 35 MM ASA T: 11 P:
NEGATIVE LOCATION: FNP FOLDER FILE # 22098843809
PROCESSED BY: U.S. EPA GRAPHIC ARTS
PHOTO #: 1 # 28

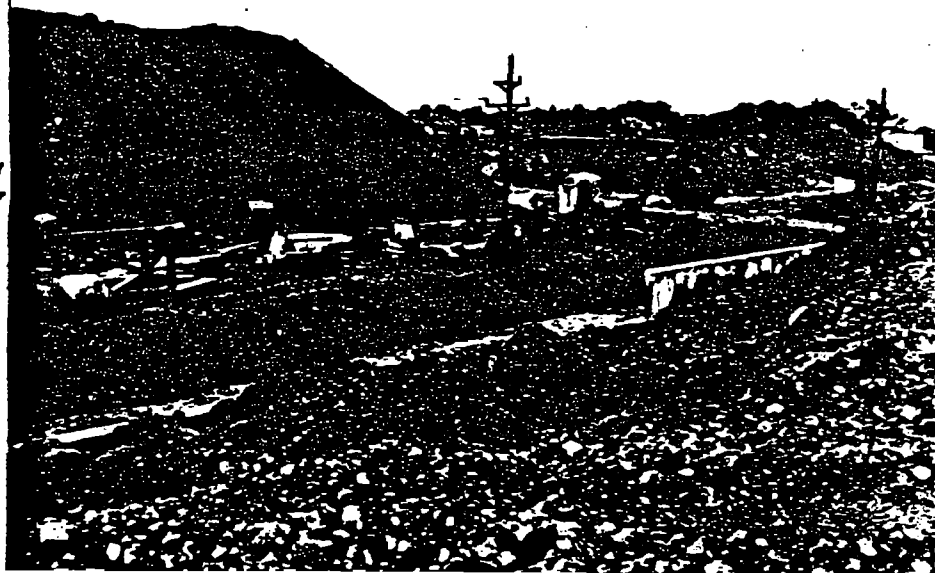
PROJECT/CASE NO: CHEMETCO SITE VISIT
SUBJECT: Southwest side of Slag Pile. Partial views of 2nd Slag Pile and east side of Scrap Yard
LOCATION: Northeast side of facility
CITY: HARTFORD COUNTY: HARTFORD STATE: ILL
DATE: 5-28-86 TIME: 11:15 AM
WEATHER: (SUN) (HAZE) (CLOUDY) (RAIN) (SNOW)
PHOTOGRAPHER (S): Joel McKell from Chemetco
WITNESS: James E. Goff & James Mayka
CAMERA: CHEMETCO'S PROPERTY
FILM TYPE: 35 MM ASA T: 11 P:
NEGATIVE LOCATION: FNP FOLDER FILE # 22098843809
PROCESSED BY: U.S. EPA GRAPHIC ARTS
PHOTO #: 3 # 28

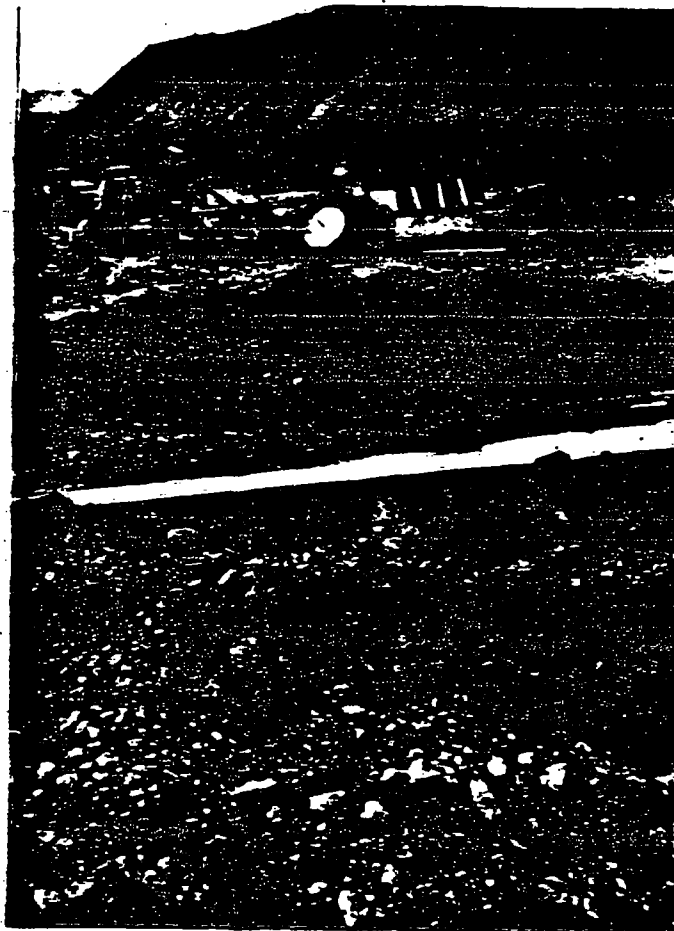
Cooling Canal A recirculating canal (surface impoundment) surrounds the slag piles. The canal, which is not lined, was used for the storage of non-contact cooling water for the scrubber system until October of 1984. Liquid from the old ZnO pits was also pumped into the canal. IEPA tests have shown that the canal sediment contains hazardous levels of cadmium and lead. These metals were also found in the water contained in the canal. In addition, IEPA files contain evidence that runoff from this canal drained across Chemetco's property line over adjacent fields.

Although the canal is currently used for the storage of rainwater only, the presence of slag was observed, at the bottom and on the sides of the canal.

PROJECT/CASE NO: CHEMETCO SITE VISIT
SUBJECT Concrete wall that surrounds Scrap Yard. Also,
LOCATION Recirculating Cooling Canal at the base of Slag Pile
North-Central area of the facility

CITY: HARTFORD COUNTY: MADISON STATE: ILL
DATE: 5-28-86 TIME: 11:15 AM
WEATHER: (SUN) (HAZ) (CLOUDY) (RAIN) (SNOW)
PHOTOGRAPHER (S): Joe McKell
WITNESS: Quana E. Rojo & James Mayka
CAMERA: CHEMETCO'S PROPERTY
FILM TYPE: 35MM ASA T.I.: 1
NEGATIVE LOCATION: ENP Folder FILE # ELDOR 843879
PROCESSED BY: U.S. EPA GRAPHIC ARTS
PHOTO #: 4 of 28

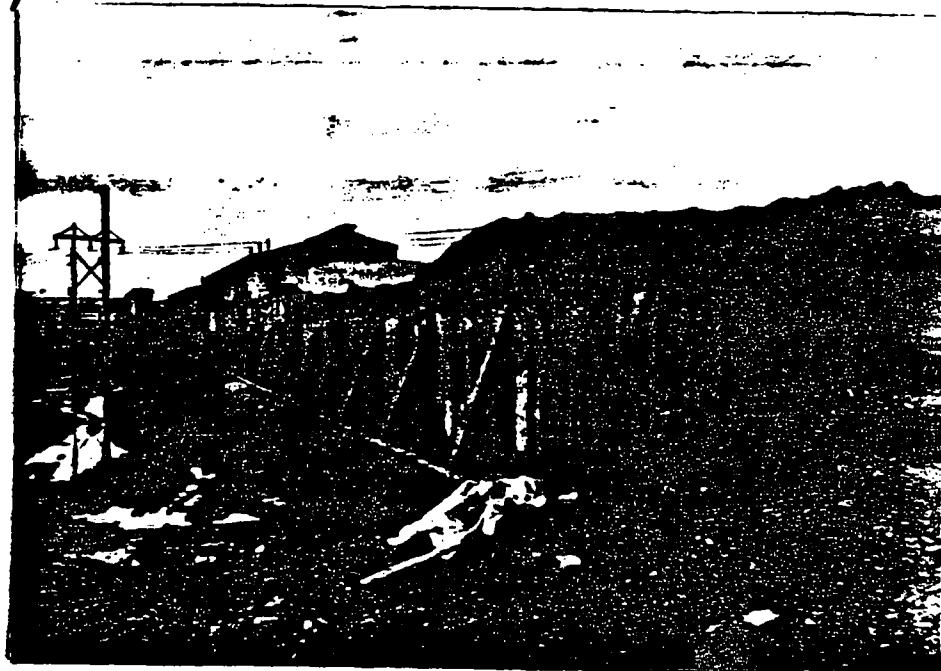
The slag and zinc oxide piles are placed next to each other on a concrete pad measuring over 300 feet on each side and surrounded by concrete walls several feet tall (still in construction). Both materials were placed on the ground prior to the construction of the concrete pad. Hazardous levels of lead and cadmium have been found in the piles.

PROJECT/CASE NO: CHEMETCO SITE VISIT
SUBJECT Concrete wall & pad where Scrap Yard has been placed
LOCATION North-central area of the facility
(Foundry is in the background towards South)

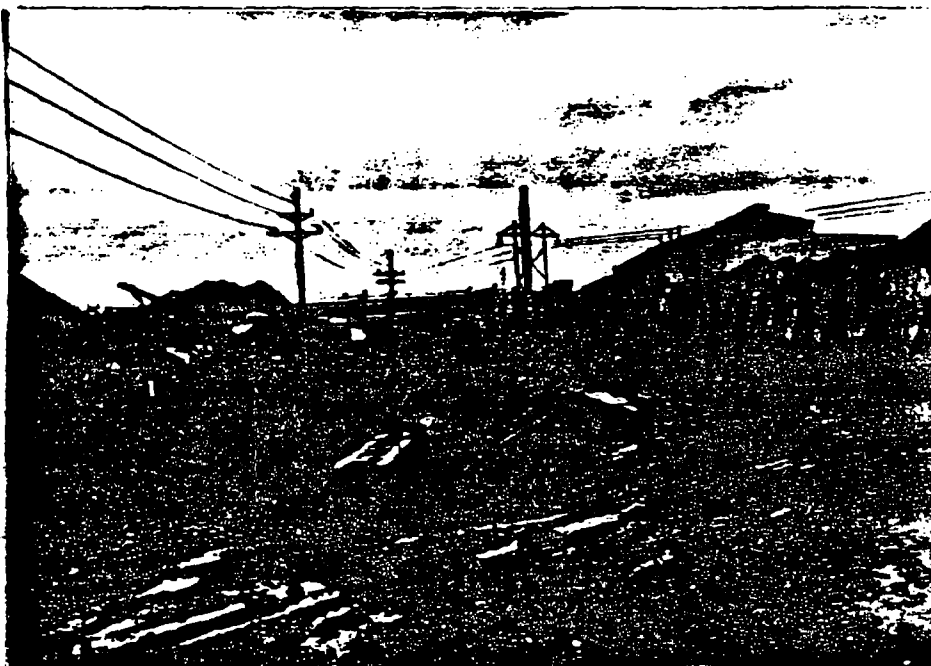
PROJECT/CASE NO: CHEMETCO SITE VISIT
SUBJECT Recirculating cooling canal
LOCATION Northcentral area of the facility
CITY: HARTFORD COUNTY HADISON STATE ILL
DATE 5-28-86 TIME 11:30
WEATHER (SUN) (HAZE) (CLOUDY) (RAIN) (SNOW)
PHOTOGRAPHER (S&S) Joanna E. Boyer
WITNESS Joe McKell & James Mayka
CAMERA CHEMETCO'S PROPERTY
FILM TYPE 35MM ASA 11
NEGATIVE LOCATION ENP FOLDER FILE # 820048843209
PROCESSED BY: U.S. EPA GRAPHIC ARTS
PHOTO # 7 28

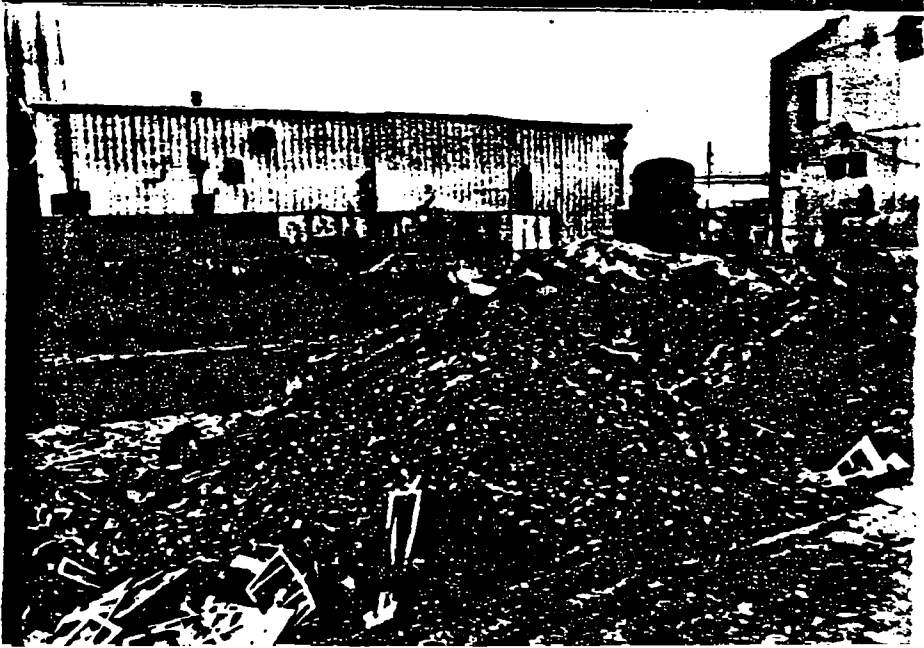
PROJECT/CASE NO. CHEMETCO SITE VISIT
SUBJECT Smoky slag from foundry surrounded by raw material
LOCATION West-central area, north of the foundry
CITY NANTFORD COUNTY MADISON STATE ILL
DATE 5-28-86 TIME 11:45
WEATHER (SUN) (HAZE) (CLOUDY) (RAIN) (SNOW)
PHOTOGRAPHER (Sg.) Quana E. Rios
WITNESS Joel Mc Kell & James Mayka
CAMERA CHEMETCO'S PROPERTY
FILM TYPE 35MM ASA 111 1
NEGATIVE LOCATION FNP Folder FILE # 22098843809
PROCESSED BY: U.S. EPA GRAPHIC ARTS
PHOTO # 10 28

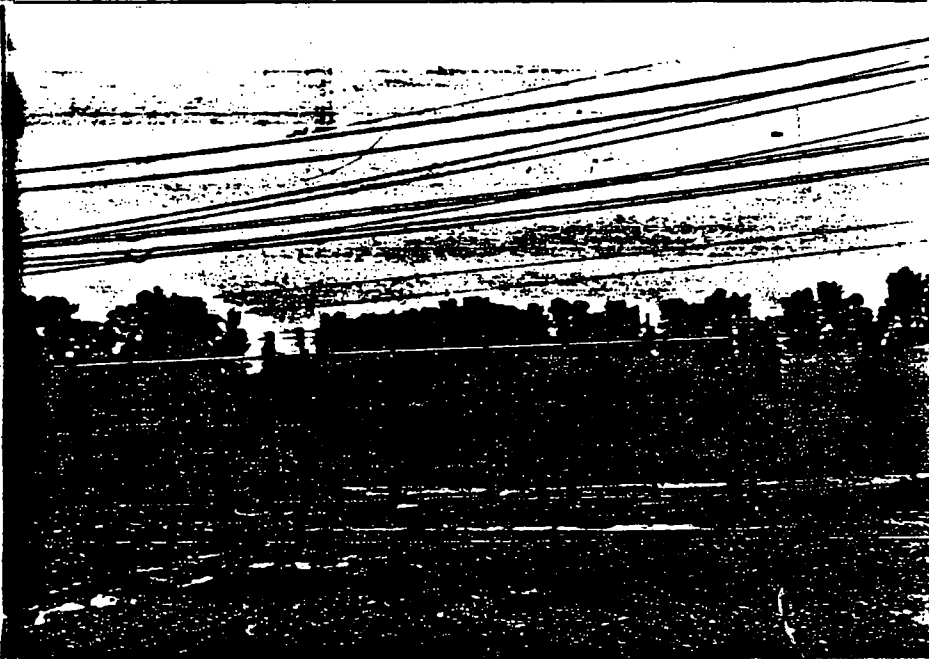
Distressed Vegetation Area The liquid wastes from the acid pit and the acid recovery ditch, saturated the soil and the subsoil of the area located on the south side of the Oldenburg Road, damaging the vegetation and causing discoloration of the soil. Presently, Chemetco has been trying to remove the liquid wastes from this area. A large, perforated tank, buried in the acid-soaked area, collects the liquid waste, which is then pumped back into the plant.

SUBJECT Distressed vegetation on the south side
of the facility

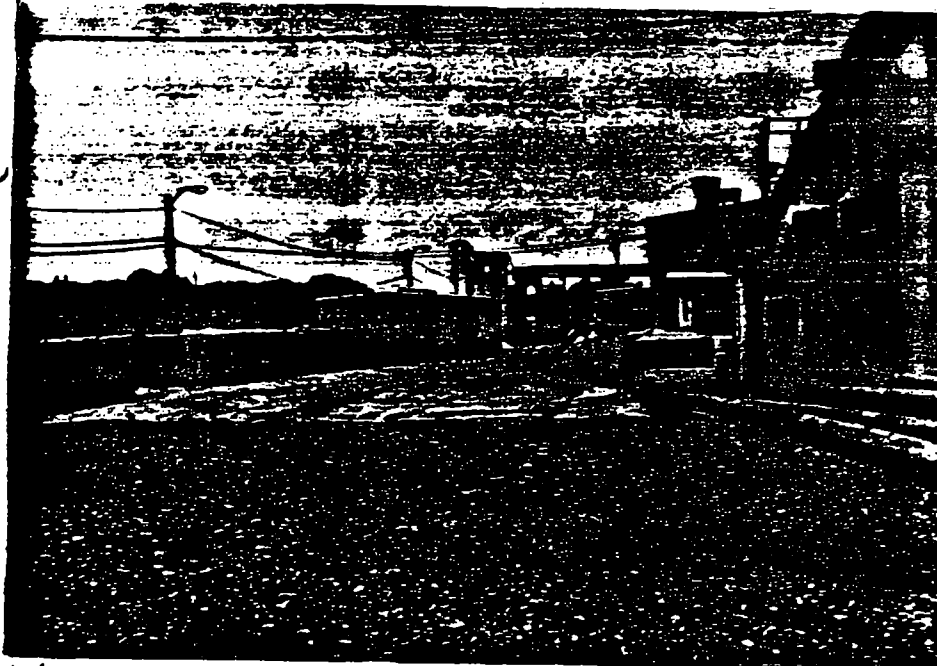
SUBJECT Slime bunker & electrolys tanks & section of closed
acid pit area.

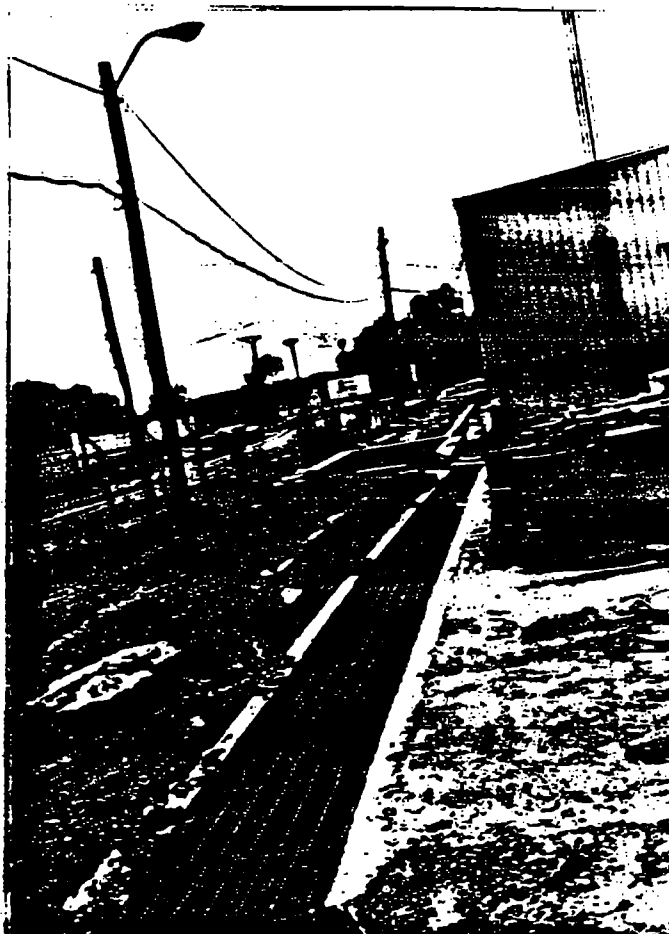
PROJECT/CASE NO. CHEMETCO SITE VISIT
SUBJECT Runoff Collection System (concrete lined)
LOCATION Southeast side of the
facility (still in construction)
CITY HARTFORD COUNTY MADISON STATE ILL.
DATE 5-28-86 TIME ~2:00 PM
WEATHER (SUN) (PAZ) (CLOUDY) (RAIN) (SNOW)
PHOTOGRAPHER (S) James F. Kline
WITNESS Joel Tucker & James Hayka
CAMERA CHEMETCO'S PROPERTY
FILM TYPE 35 MM ASA T11 P
NEGATIVE LOCATION FHP File # 3609884389
PROCESSED BY: U.S. EPA GRAPHIC ARTS
PHOTO # 28 28
